WABASH RIVER BANK MITIGATION WORK PLAN FORMER WESTERN TAR FACILITY TERRE HAUTE, INDIANA

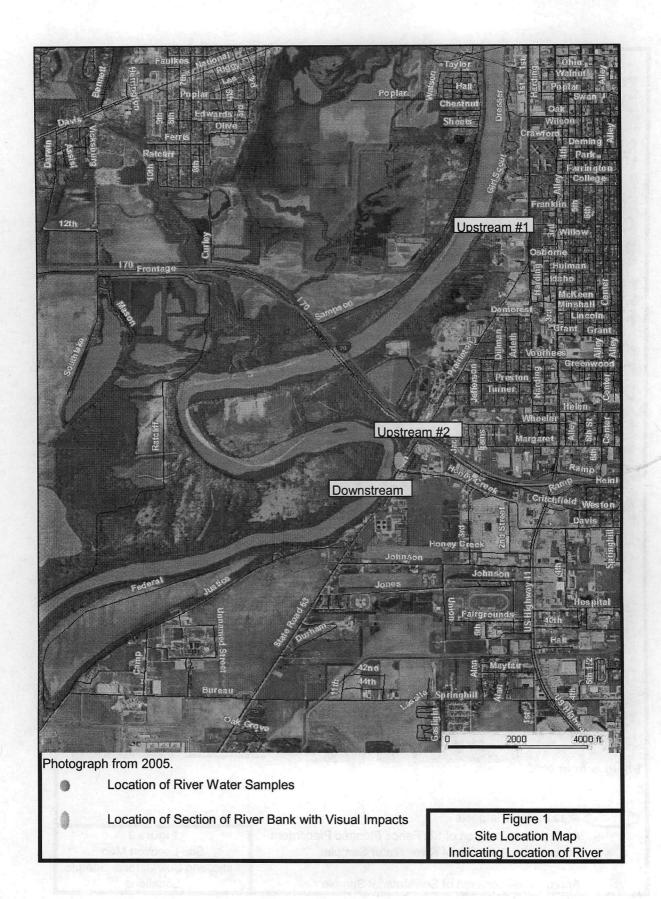
| <u>Sectio</u> | <u>on</u> | Page |
|---|---|---|
| 1 2 3 | Site Location Map Showing River Water Sample Locations Site Location Map Showing Soil/Material Sample Locations Photographs of Site Location and examples of impact types | |
